REDUCE, REUSE, RECYCLE

WASTE NOT, WANT NOT

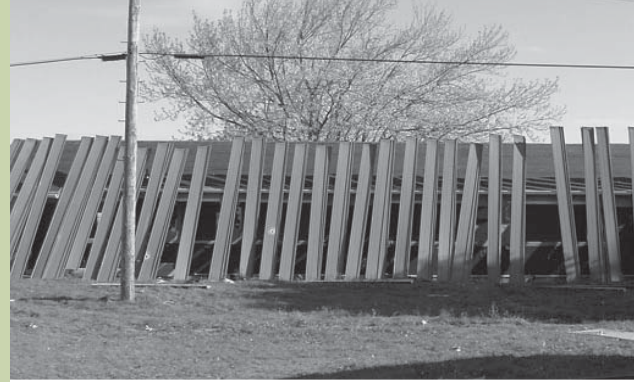
Salvaged metal roofing ready to be removed from the site.

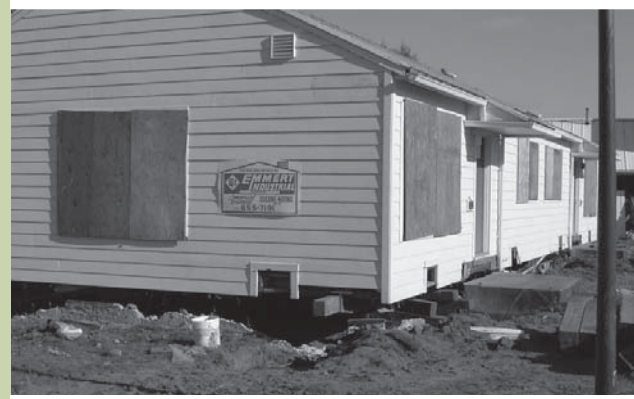
A building on blocks is prepped to move.

23 of Columbia Villa’s duplex buildings were purchased by local house moving companies, unbolted from their foundations, and removed from the site intact.

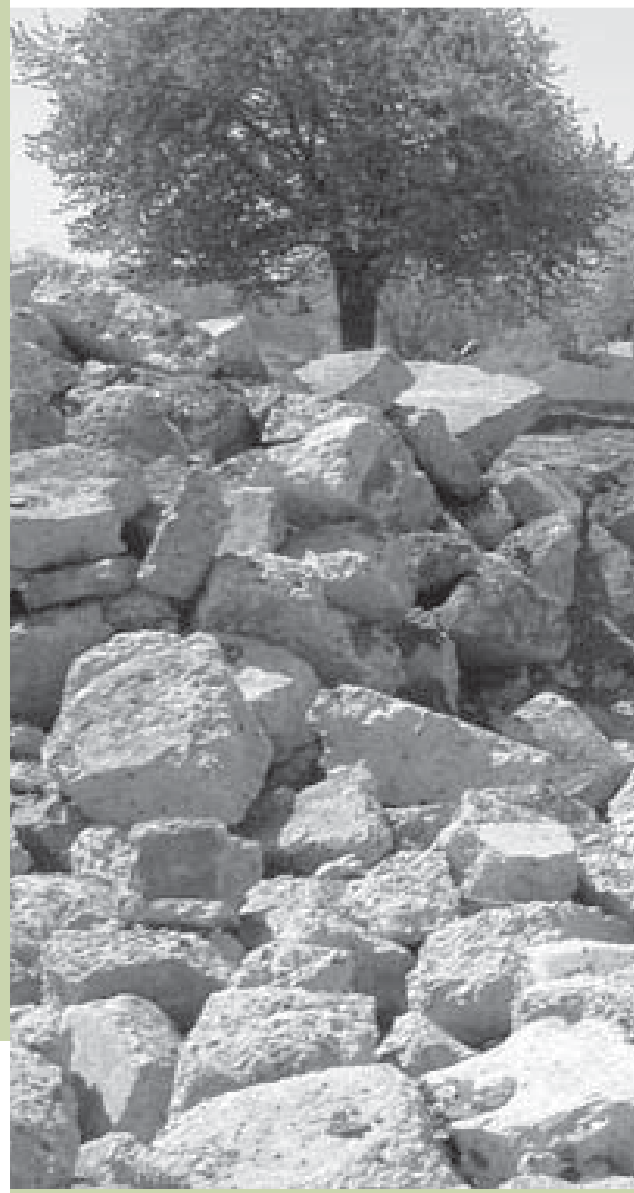
A large pile of concrete rubble waits to be ground up and reused.

100% of the concrete and asphalt rubble generated by the demolition of Columbia Villa—all 22,000 tons of it—was ground into gravel-sized pieces and reused on site as road base and structural fill around building foundations. The rubble made a road base so strong that contractors could drive heavy construction equipment on it during the winter months before final paving was completed.
